Survey of Oakley Wood Camp

Friends of Oakley Wood

August 2021

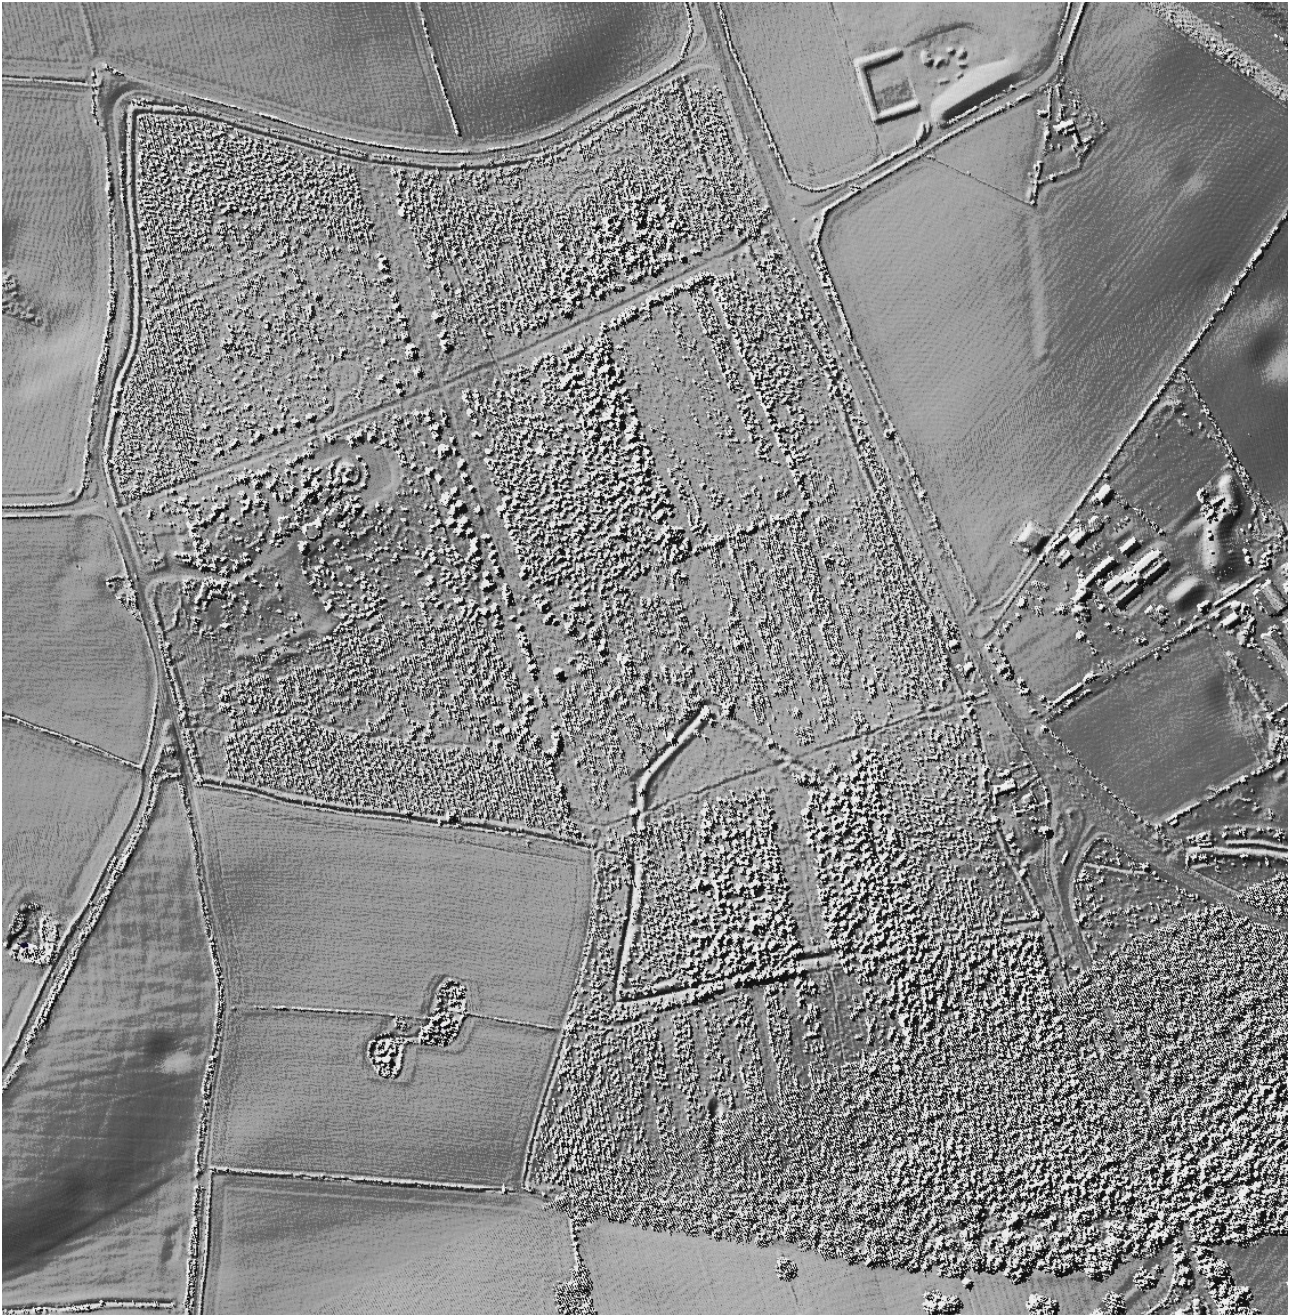
The LiDAR image shows the camp and other earthwork features in Oakley Wood. A zoomable version of this image is available at <https://houseprices.io/lab/lidar/map?ref=SP3071259287>.

The LiDAR image is not dated, but using historic knowledge of paths in the wood and features in nearby Leamington Spa this map is estimated to be about 15-20 years old i.e. around the turn of the millennium.

The diagonal line across the bottom right corner of the image appears to be an artefact and doesn't correspond to any real feature on the ground. It looks like the image has been created from two sets of data captured at different times, the upper part in the winter and the lower during the summer when there was more tree foliage.

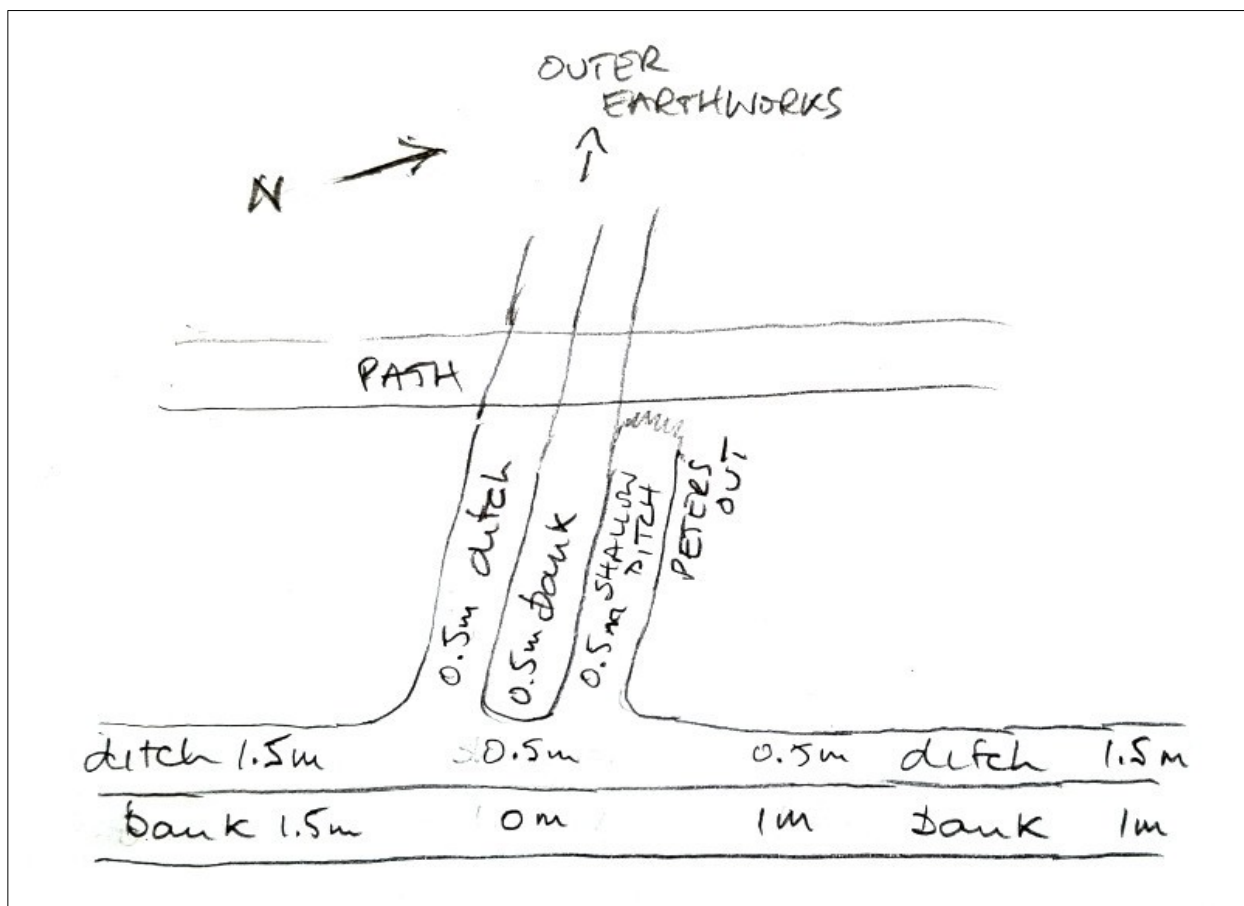
Figure 2: Junction at P1

At c. 30m S of this path there is a junction (point P1) with another ditch & bank that run W along the boundary of the wood and form part of the outer earthworks (see Figure 2).

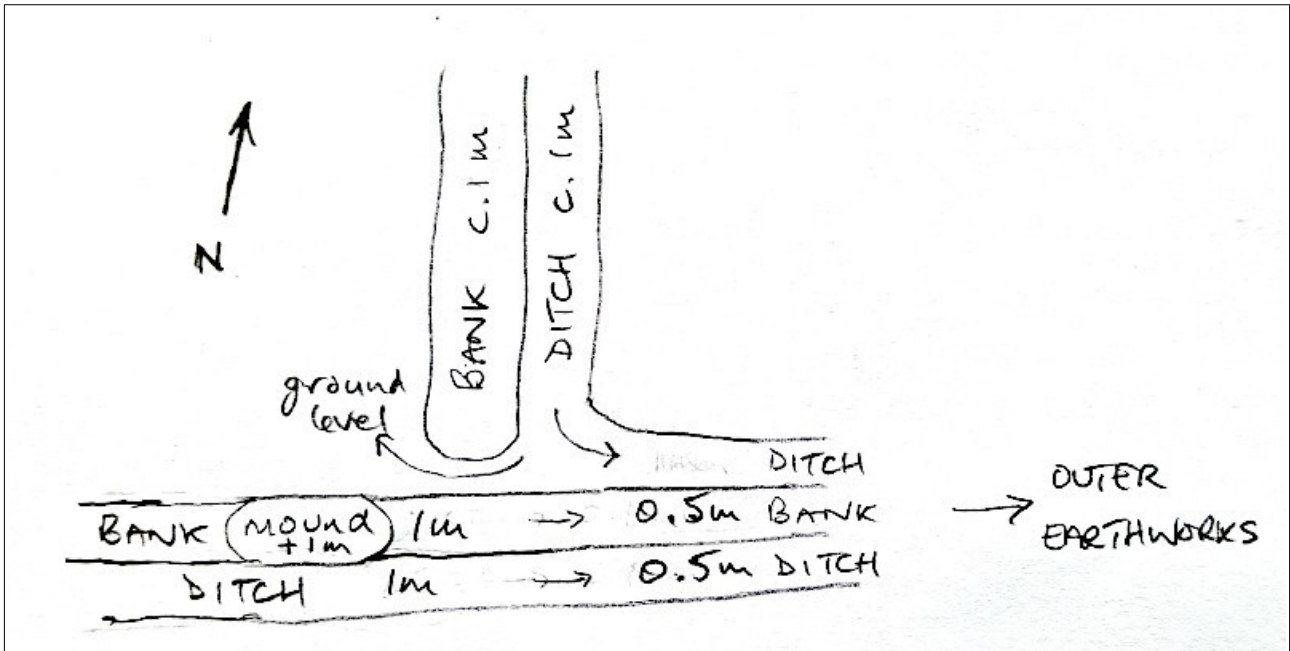
Figure 3: Junction at P3

The section ends at D with a significant mound on the bank (reminiscent of the mound at A) where it meets the bank from the north (photo C6). This junction at apex D (point P3) is shown in Figure 3, and could suggest a possible narrow entrance from the ditch where the two banks do not quite meet. The ditch from the N takes a right angle left (eastwards) and runs inside the lowered embankment as an inner ditch for c. 30m - this is an estimate as it is completely overgrown and impossible to see, but does not extend as far as the N-S path that runs near the easternmost boundary of the wood.

The ditch and bank that continue ENE towards the boundary of the wood are less deep and high than those surrounding the camp. They terminate at a private garden where they join the outer earthworks that surround the wood.

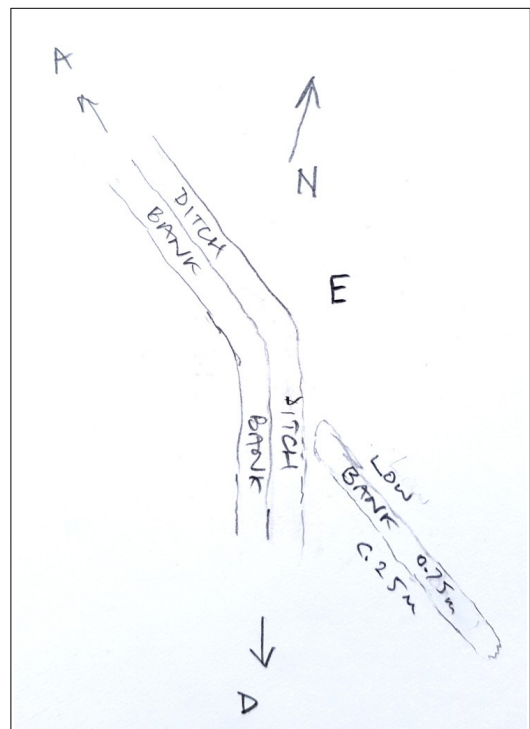
Figure 4: Bank leading from apex E

At apex E there is some evidence of a low bank c. 0.75m high that continues SE on the same line as the E-A embankment for a distance of at least c. 25m. There is no apparent ditch at this point, although some traces appear further on.

On further investigation, and with help from the LiDAR image, it's possible to follow traces of this bank and ditch towards the edge of the wood and beyond. It reappears cutting through the corner of the adjacent Wiggerland Wood (bh c. 0.5m bw c. 5m, dd c. 0.75m dw c. 3m) and is still visible for a short distance on the other side of the B4100.

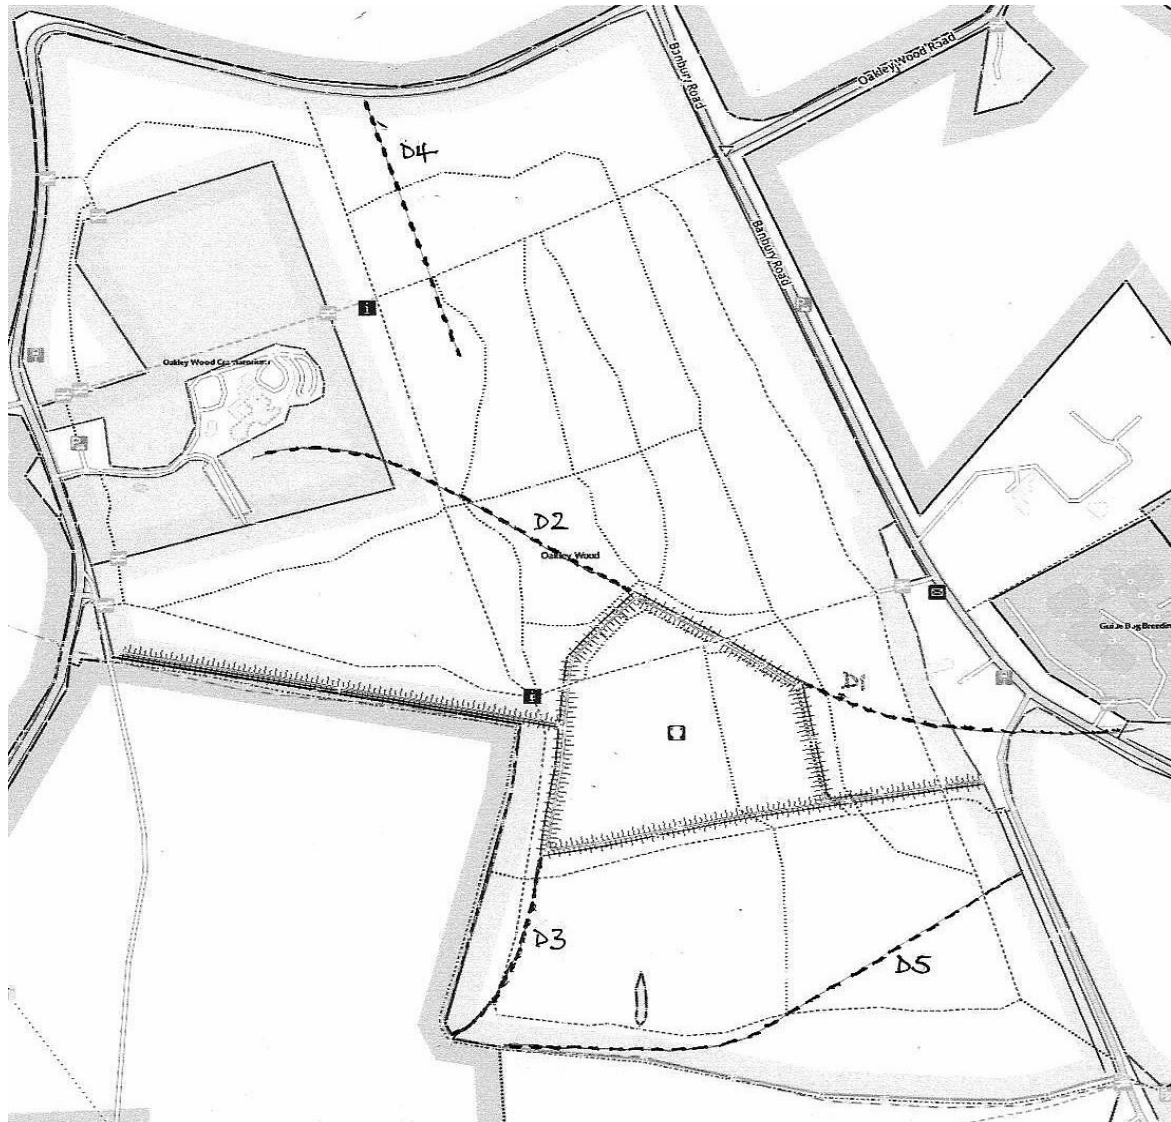
Figure 6: Other connected earthworks

- As previously described, there are the remnants of a ditch and possible bank leading from the NE apex (point E) in a SE direction (ref D1).
- The LiDAR image shows a faint line running NW from the north apex (point A) and curving into the Crematorium grounds. This is a ditch, detectable outside the Crematorium fence, with little evidence of a bank. It crosses the main path (visible only as a slight depression), becomes fairly prominent c. 50m further on with a definite bank on the SW side and is intermittently visible for

- c. 50m more when any further traces from here to the north apex have been obliterated by the recent logging operations (ref D2).
- The LiDAR image suggests that the ditch already identified leading S from the SW apex (point C) actually continues to the southern boundary. Further investigation shows this to be true although the ditch is poorly defined and difficult to follow due to being overgrown. It crosses the N-S path obliquely and continues to the wood boundary (ref D3).

- A straight N-S ditch runs S from OP7 c. 0.5m deep becoming more shallow c. 0.3m deep, crosses the main E-W Crematorium-B4100 path at the lowest point (of the path, suggesting a drainage ditch) and continues straight for an undetermined distance (ref D4).
- A ditch c. 1m deep c. 2m wide runs from OP13 in a SW direction into the wood. Because of the undergrowth it is difficult to follow, but there are various places where a ditch is visible running in apparently the same direction. One such place is crossing the path at OP14 running in a SW direction, and visible intermittently until it reaches the S boundary. It seems likely that these are all parts of one continuous ditch and are shown as such in the diagram (ref D5).
