Survey of Oakley Wood Camp

Friends of Oakley Wood

August 2021

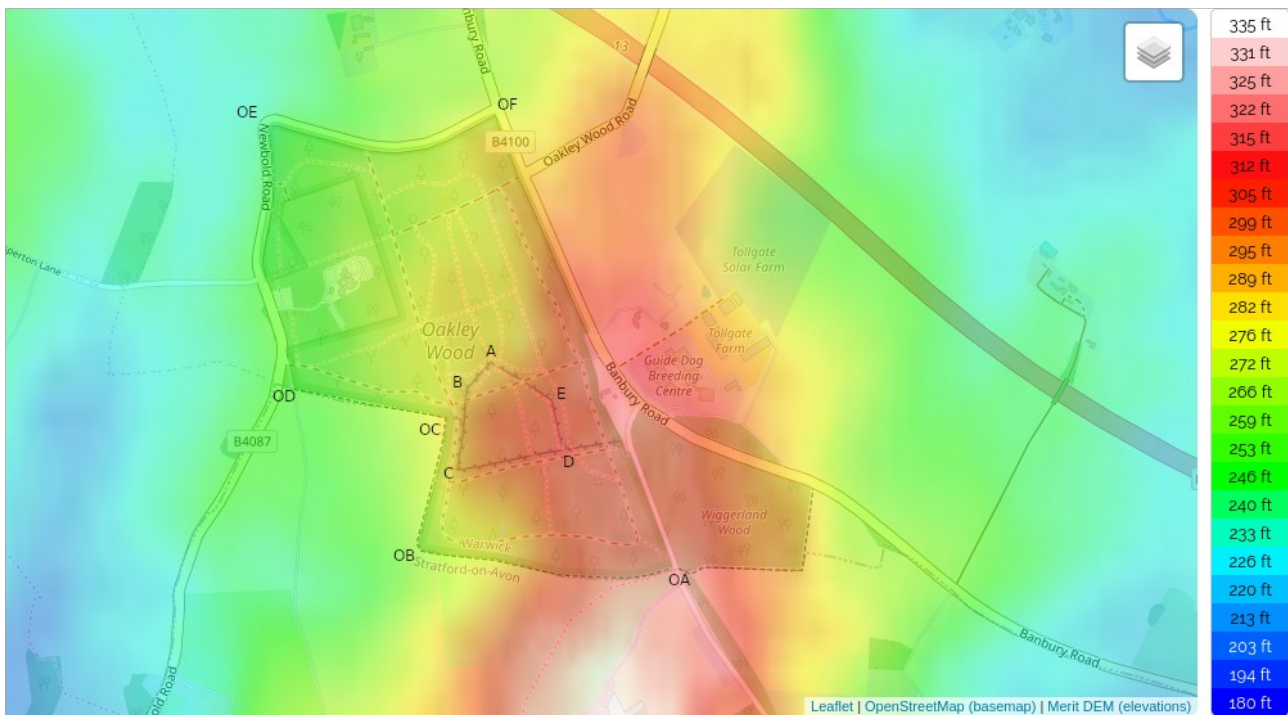
The elevation map above (<https://en-gb.topographic-map.com/maps/sihq/West-Midlands/>) shows that the camp is on raised ground extending from a N-S ridge, and overlooking the valley to the W.

The elevations (in ft.) from this interactive map of the camp reference apex points are: A 286, B 283, C 285, D 309, E 306. Intermediate points within the camp show it to be mostly level at just above 300ft, sloping downward towards the N, W and SW.

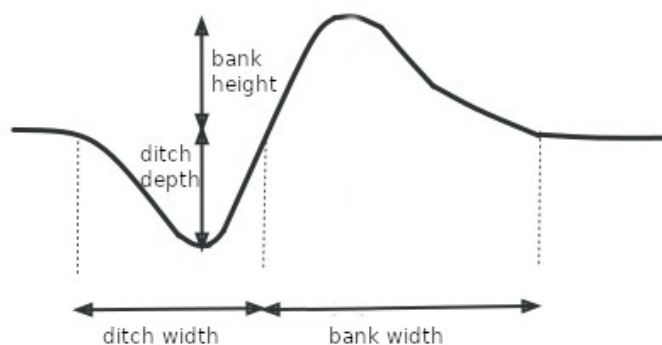
To avoid any uncertainty, these are the dimensions that the measurements referred to:

Measurements are given in tables. If included in the text, these abbreviations are used: bh (bank height), bw (bank width), dd (ditch depth), dw (ditch width).

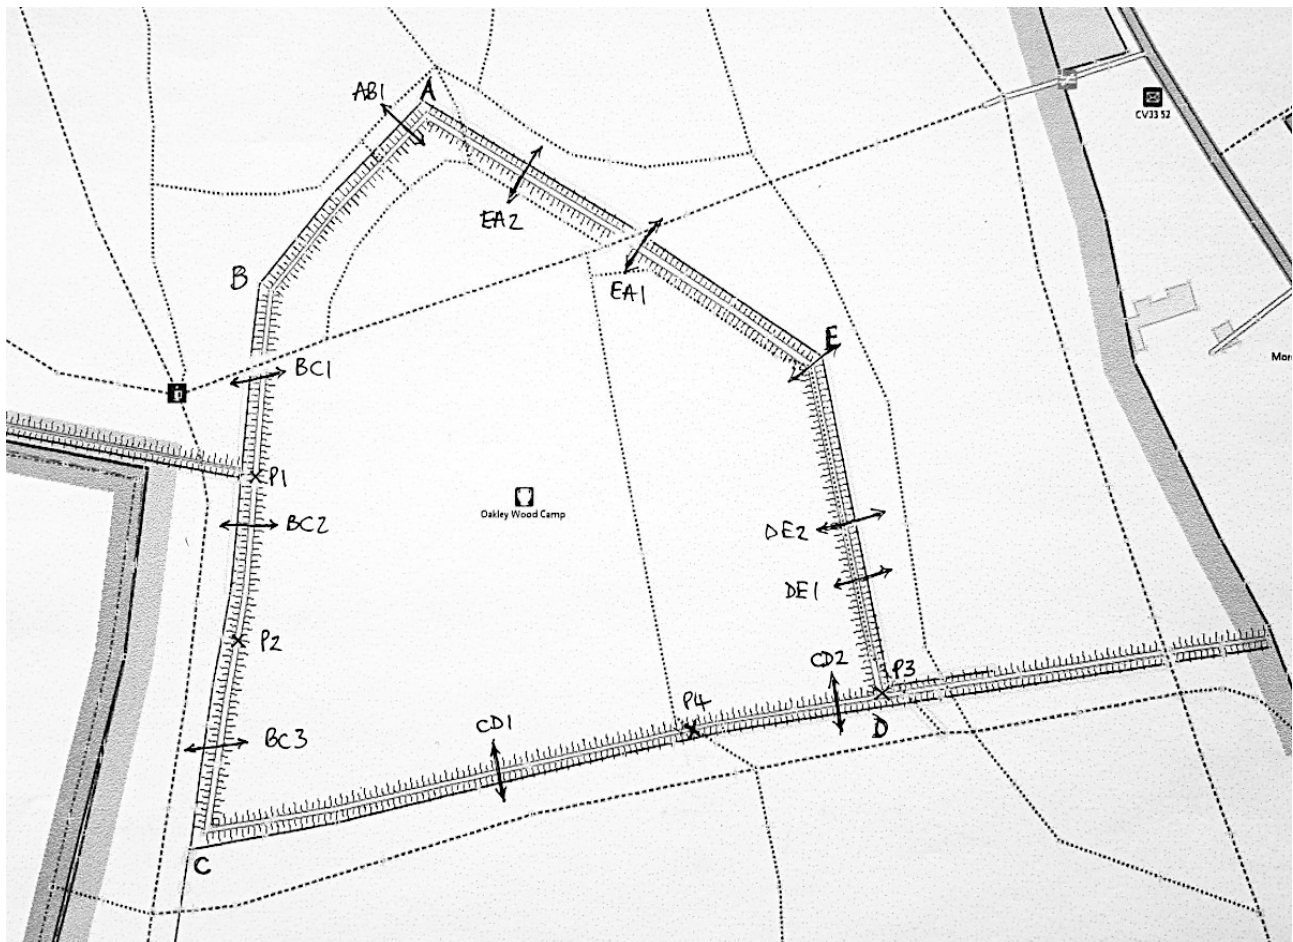
Figure 1: Inner earthworks - reference

This diagram shows the camp apex markers, measurement locations and other points identified in the survey and referenced in this document.

The area of the camp bounded by the embankments is 3.8 ha. (JOSM Measurement plug-in)

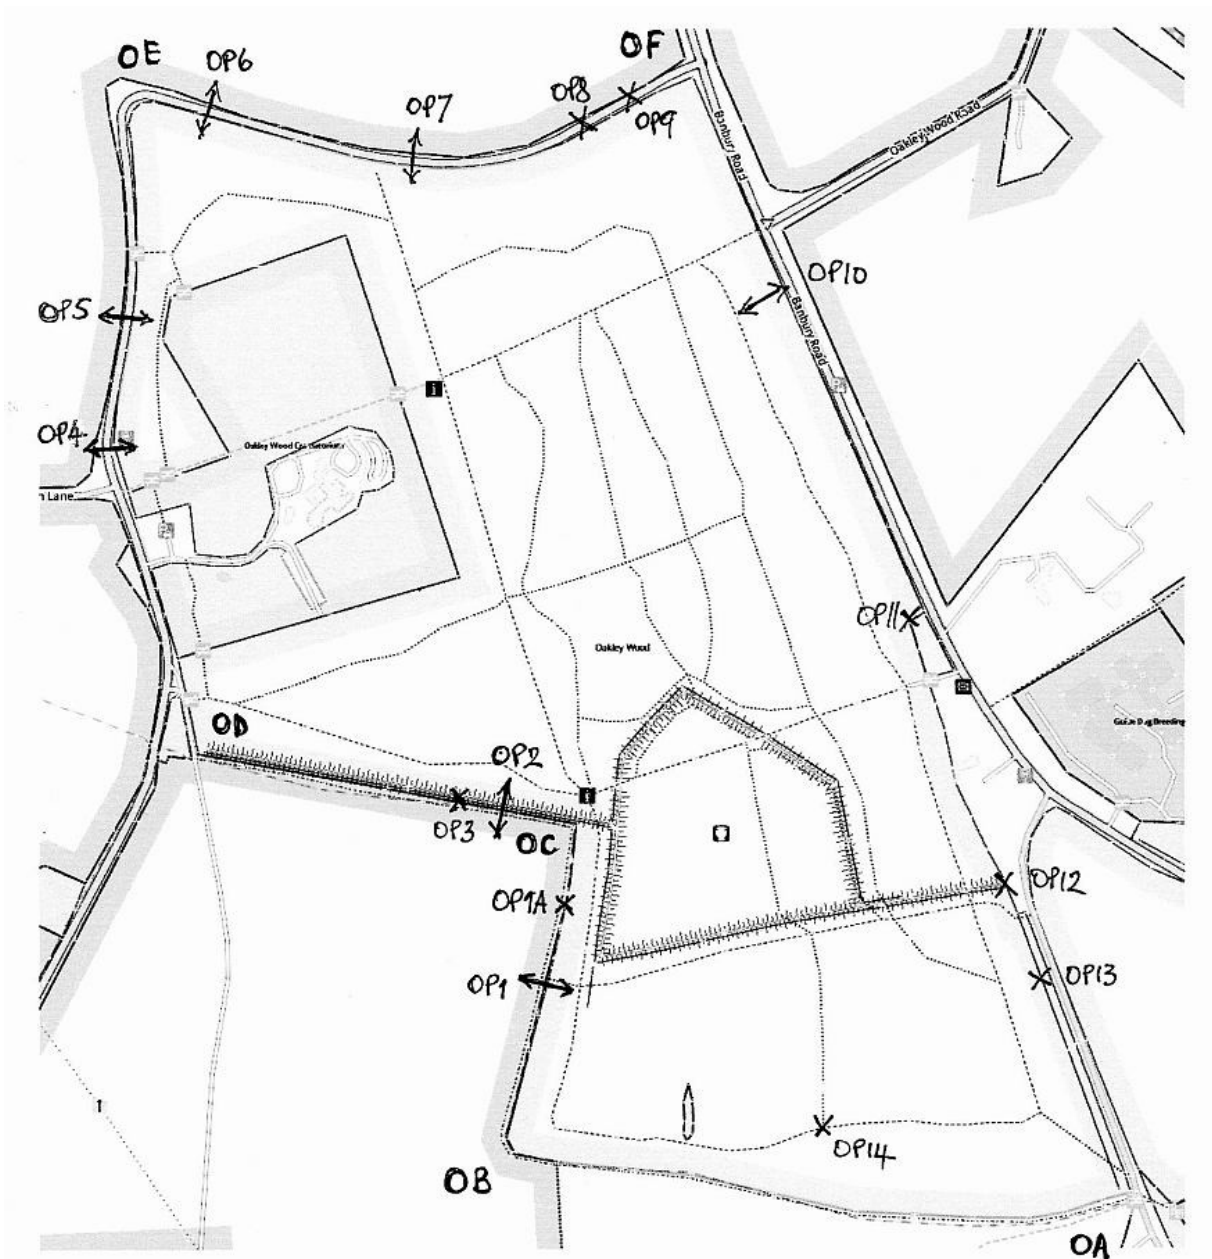
Figure 5: Outer earthworks - reference

Oakley Wood is approximately rectangular with a roughly square-shaped field cut out of the south-west corner. Earthworks that are clearly visible on the LiDAR image run along the boundary of the wood to the west and north, and c. 20-40m inside the eastern boundary formed by the B4100 Banbury Road to the Moreton Morrell Road junction. However, much of the southernmost boundary has none.
